Case History No.12 MOTOR DRIVE PULLEY STEADY BEARING FAILURE

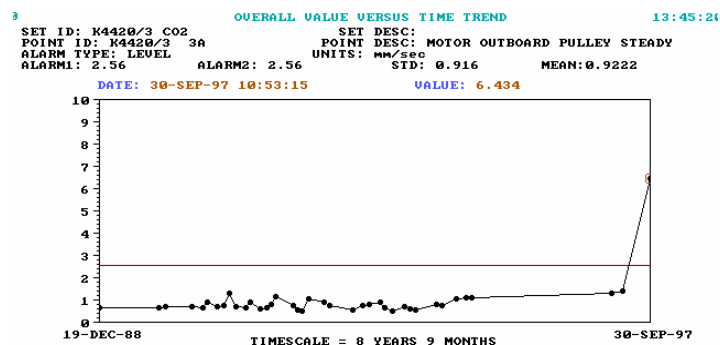
Historically, the overall vibration levels throughout the machine had been consistently low (around 1.4 mm/s rms) and had never given any cause for concern, however, the overall vibration levels recorded on the 30th September 1997 at the motor drive pulley outboard steady bearing exhibited a marked increase in the axial direction (position 3A), see Figure 2 below.

Figure 2 - Motor outboard pulley steady bearing

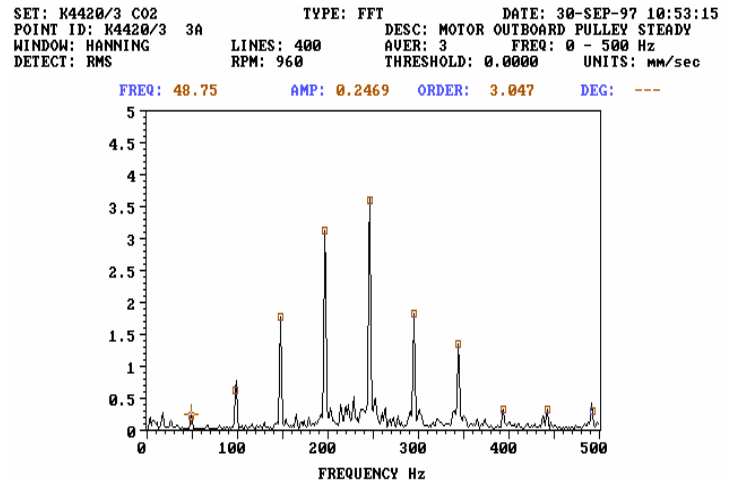
Examination of the vibration spectrum collected from this location exhibited several harmonic peaks across the 500 Hz bandwidth indicating a possible bearing defect at this location, see Figure 3.

Figure 3 - Vibration spectrum indicating suspected bearing damage

The site Mechanical Engineer was immediately made aware of the change in the vibration levels with a recommendation to replace the bearing as soon as possible.

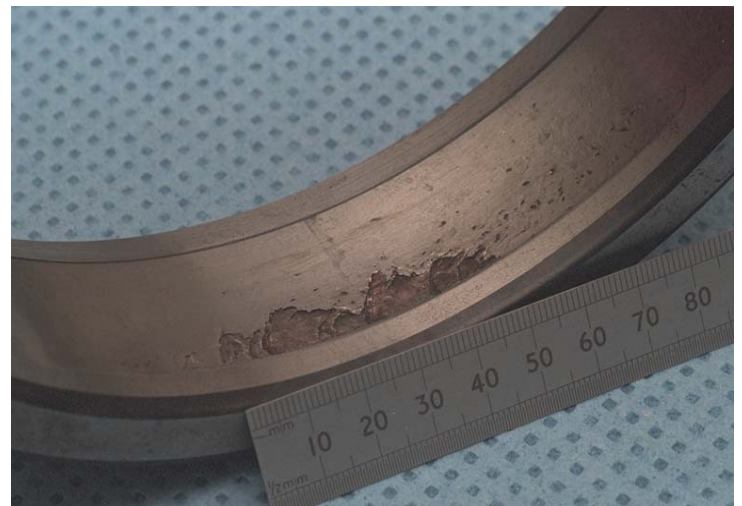
The machine was subsequently taken off line and the bearing replaced. On examination of the original bearing, a large area of flaking (spalling) was evident on the outer race, see Figure 4.

Figure 4 - Photograph showing bearing outer race damage
