Case History No.12 MOTOR DRIVE PULLEY STEADY BEARING FAILURE

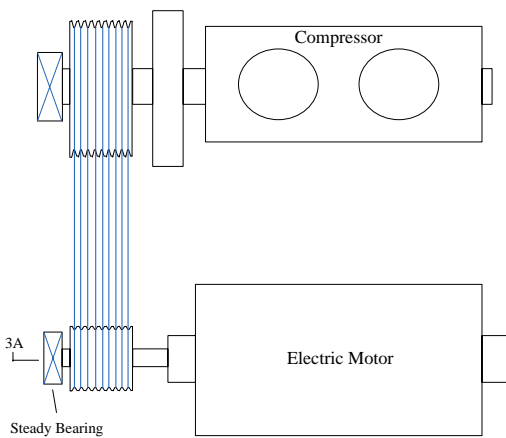
This machine forms part of a monthly vibration monitoring schedule and is one of a team of three identical units that produce CO₂ for the chlorine liquefaction process, Figure 1 below shows the layout of the machine.

Figure 1 - Two stage reciprocating compressor
